Case Report

CT-Angiogram Appearance of Iatrogenic Azygos Vein Perforation

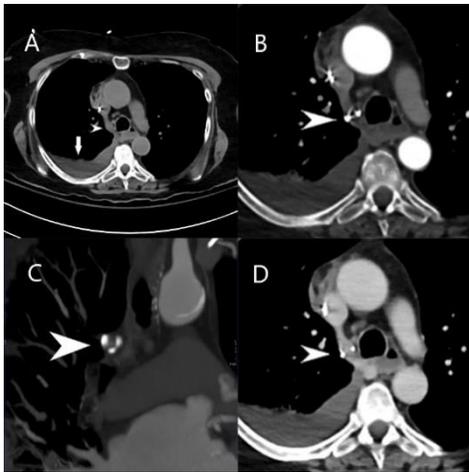
Figure 1: CT-Angiogram of the case.

Non contrast axial image **A**) demonstrating a dense right-sided pleural effusion consistent with a hemothorax (arrow) and an enlarged but isodense and homogenous azygos vein (arrowhead). After bolus pressured contrast injection from the right upper arm, reflux in the azygos vein from the superior vena cava occurred (not imaged). Few seconds later, contrast enhanced arterial phase acquisition was obtained with axial **B**) and coronal **C**) images showed here. Not visible on non-contrast images, a ring of dense contrast is now seen at the periphery of the azygos vein (arrowhead), which corresponds to accumulation of contrasted under leaflet of venous valvulae, not to be confound with active extravasation of blood nor pseudoaneurysm. The site of the iatrogenic perforation is not visible, probably clogged. The contrast accumulation is denser than the contrast in the vessel, which is different

from a pseudoaneurysm, where the contrast would be the same in the vessel and in the defect on all phases. On axial contrast enhanced image in venous phase **D**), the ring is still denser than the vessel (arrowhead) and keeps the same shape, which confirm that there is no active extravasation of blood since ongoing bleeding will tend to increase in size from arterial to venous phase. These findings suggest that the contrast is contained and trapped under the valvulae leaflets since veins, by their anatomic constitution, do not dissect. A 72-hours CT-angiogram (not shown) depicted the same image which confirms the non-acute nature of this appearance.

If the patient is intubated, high levels of positive-end expiratory pressure (PEEP) can increase pressure in the pleural space during the respiratory cycle, promoting tamponade of the bleeding. For the same reason, drainage of the pleural blood effusion should be delayed if possible. Turning the patient of his left side is also believed to decrease venous pressure in the right sided azygos vein [2].
