# Unusual Case of Acetabular Liner Dissociation Following Failure of Ceramic-On-Ceramic Bearing Total Hip Arthroplasty: A Case Report

Michael Foxall-Smith, Richard Donovan, Stephen Eastaugh-Waring and Mehool Acharya\*

Avon Orthopaedic Centre, North Bristol NHS Trust, Bristol, UK

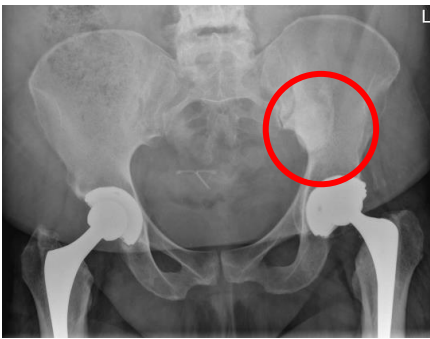
Exeter/Tritanium ceramic-on-ceramic total hip replacement 5 years before this for avascular necrosis of the left hip. Initial radiographs of the pelvis and hips demonstrated bilateral total hip replacements in situ. On the anteroposterior radiograph, it was noted that the femoral head was not centred within the acetabular component, in keeping with asymmetric wear (Figure 1). The patient had ongoing pain and re-presented to the emergency department 10 days later with a clunking sensation. Further radiographs confirmed that the femoral head was located within the acetabular component but was maintained in an eccentric position (Figure 2). Due to persistent symptoms, the patient was referred to a hip surgeon. Review of the previous radiographs taken in the emergency department revealed that there was an opacity seen in the left hemipelvis overlying the left ilium. The diagnosis of a dislocated ceramic liner was confirmed on computed tomography (CT) scanning (Figure 3). The patient was informed of this and placed on the urgent list for revision hip surgery.

**Figure 2:** AP radiograph pelvis showing opacity over left iliac blade and non-concentric position of femoral head within the acetabular component.

In this particular case, the ceramic liner had dissociated itself from the metal-backed liner and had migrated superiorly into the pelvis. This has not been described before in the literature and we suggest that it might have taken the route along the iliopsoas in a retrograde manner or posteriorly along the piriformis via the greater sciatic notch.

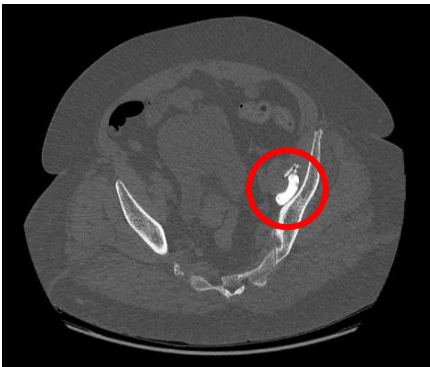
**Figure 3:** Axial CT radiographs. The dissociated component is ringed in red.

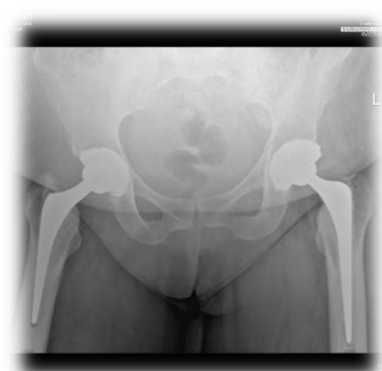
uneventful postoperative recovery and reported no problems with the dislocated migrated ceramic liner retained within the pelvis (Figure 4).

**Figure 4:** Post operative radiograph after revision hip surgery.

During the revision surgery, the ceramic femoral head was seen lying in the metal acetabular component. The ceramic acetabular liner was not seen, nor was there any evidence of ceramic debris. The liner and head were changed to a Stryker dual-mobility construct. The patient made an
