# Fracture of the Femoral Component in TKR – A Case Report

9 reports, stress fractures of the femoral component have predominantly affected the medial condyle, 6 following uncemented implantation of fixed-bearing knees. We report the case of fracture of the lateral 7 condyle of a cemented fixed TKR due to bad cementing technique.

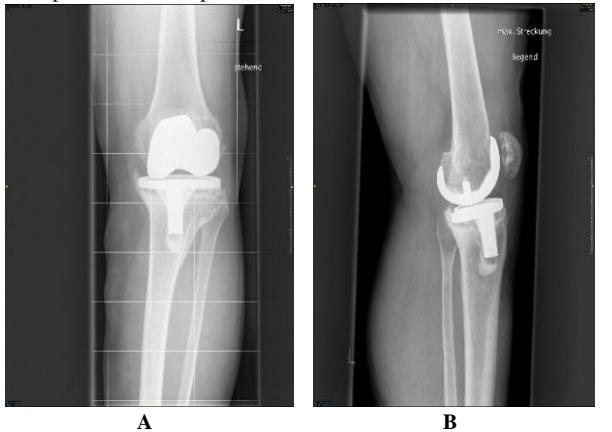
**Figure 1:** X-ray of the left knee in 2 planes: ap view (**A**) and lateral (**B**) view shows loosening of the tibial component of the PFC Sigma knee prosthesis.

In 2000 TKR of the left knee was performed elsewhere in a 55-year-old male patient due to posttraumatic osteoarthritis using a PFC Sigma prosthesis (DePuy Orthopaedics, Warsaw, IN, USA). 10 years later revision arthroplasty was performed due to aseptic loosening of the tibial component (Figure 1) using a PFC Sigma tibial prosthesis with a cemented intramedullary stem (Figure 2). Postoperative follow- up was uneventful. In 2017 the obese patient (BMI: 40.3) suffered from acute knee pain again. X-ray of the left knee showed loosening of the tibial component (Figure 3). Scintigraphy revealed enhancement in the region of the tibial and lateral femoral component (Figure 4). Revision arthroplasty of the left knee was recommended. Three weeks later x-ray in respect to preoperative planning showed fracture of the femoral component (Figure 5). Intraoperatively tibial and femoral component was found to be loose and the lateral condyle of the PFC Sigma prosthesis (DePuy Orthopaedics, Warsaw, IN, USA) was fractured (Figure 6) without attached of cement or bone. Fibrous tissue was found

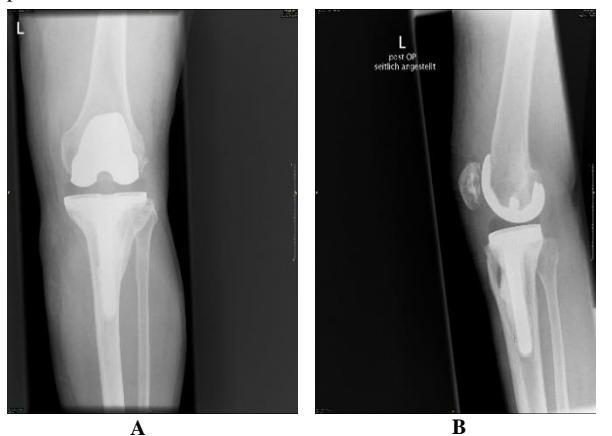
**Figure 2:** X-ray of the left knee in 2 planes after revision surgery: ap view (**A**) and lateral (**B**) view shows a cemented tibial component with intramedullary stem.

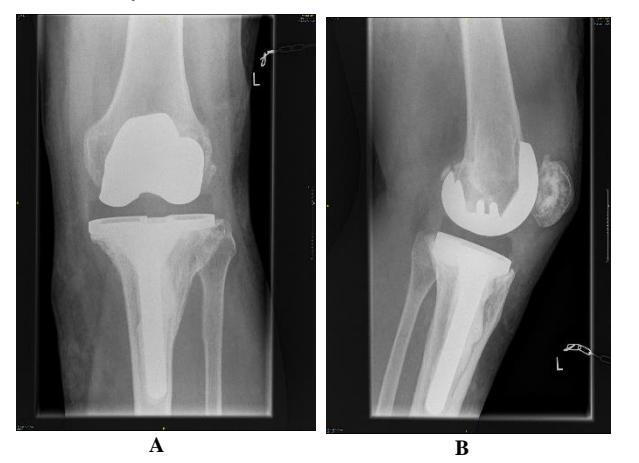
**Figure 3:** X-ray of the left knee in 2 planes: ap view (**A**) and lateral (**B**) view shows loosening of the tibial component but no radiolucent lines of the femoral component of the PFC Sigma knee prosthesis.

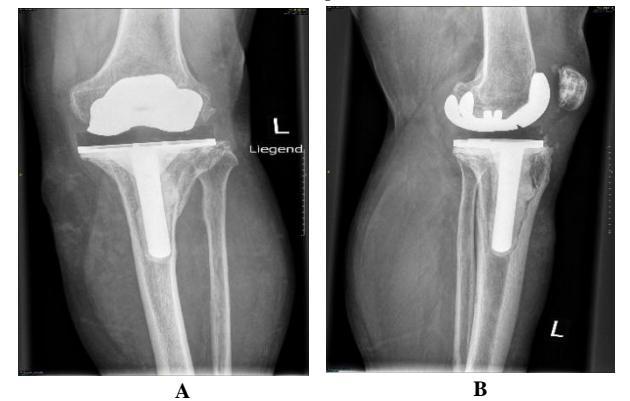
**Figure 5:** X-ray of the left knee in 2 planes: ap view (**A**) and lateral (**B**) view shows loosening of the tibial component, no radiolucent lines of the femoral component but breakage of the femoral component of the PFC Sigma knee prosthesis.

Our patient had a normal anatomic static alignment of the total knee prosthesis but was extremely obese (BMI: 40.3) The patient suffered from acute knee pain, breakage of the femoral component was missed examining first x-rays. We follow Sarraf et al. who postulated that TKR is increasing more and more worldwide [10]. An increasing number of patients is obese at index operation. In that way component fracture is likely to become a more prevalent complication. Presently, it is a rare cause of knee pain after TKR; however, surgeons should remain vigilant and maintain a high index of suspicion with a patient who presents with acute onset pain, evidence of a varus deformity, and concomitant obesity, especially since component fractures can be easily missed on plain radiography [10]. To minimize risk of that rare complication we strongly recommend well performed modern cementing techniques and optimal leg axis in TKR [15].

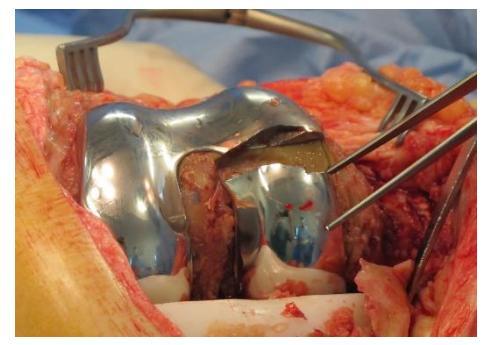
at the prosthesis bone interface around the femoral and tibial component. The cement mantle on the femoral side was incomplete. A constrained Innex SC Knee (Zimmer, Warsaw, IN, USA) was implanted (Figure 7). Postoperative follow-up was uneventful.

**Figure 6:** Intraoperative findings: Breakage of the lateral condyle of the femoral component of the PFC Knee system.

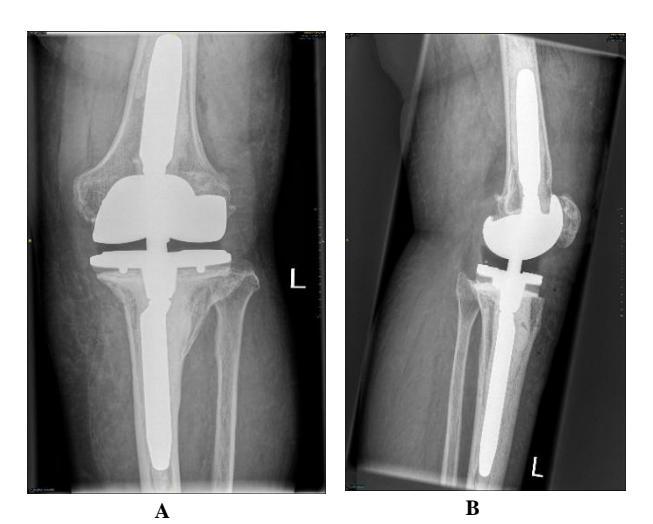
Figure 7: X-ray of the left knee in 2 planes after revision surgery: ap view (A) and lateral (B) view shows cemented constrained Innex SC Knee).
