## Case Report

# An Unusual Case of Humeral Shaft Non-Union

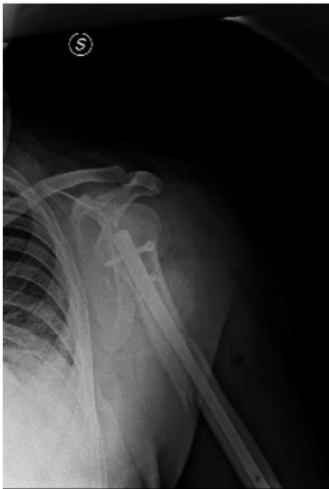
**Figure 1:** IMN of the humeral shaft fracture, post-operative radiographic check.

A 68-year-old male, unemployed, on July 2014, reported a spiroid fracture of the left humeral diaphysis (AO/Muller classification: 12-C1) due to a simple fall from a ladder. Some days later he underwent surgery, and the fracture was fixed by IMN (Figure 1). Three months later, he was clinically and radiologically followed up (Figure 2). The patient reported pain, discomfort, and function impairing, but he was suggested to continue the rehabilitation program. 7 months later, due to the increasing pain and functional impairing, the patient was diagnosed a post-traumatic humeral head avascular necrosis with an intact rotator cuff. For this reason, the IMN was removed and a cemented shoulder endoprosthesis was implanted.

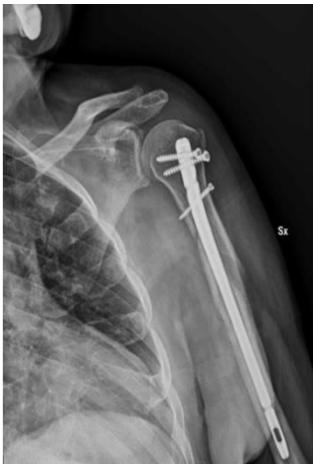
**Figure 2:** 3 months X-ray follow up, showing lack of consolidation in the site of the fracture.

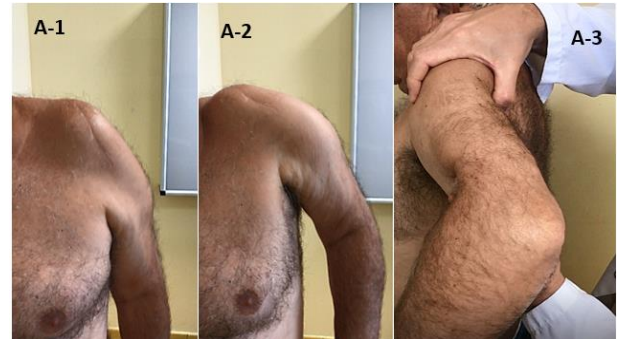
**Figure 3A:** clinical examination showing a multiplanar preternatural mobility in the middle of the arm.

on the left shoulder despite the prosthesis. The clinical and radiological evaluation was impressive (Figure 3). The patient discomfort was due to the presence of a “second elbow” in the middle of the arm with a preternatural mobility caused by an atrophic non-union of the humeral shaft. On July 2017, 3 years after the first operation, the patient underwent new surgery.

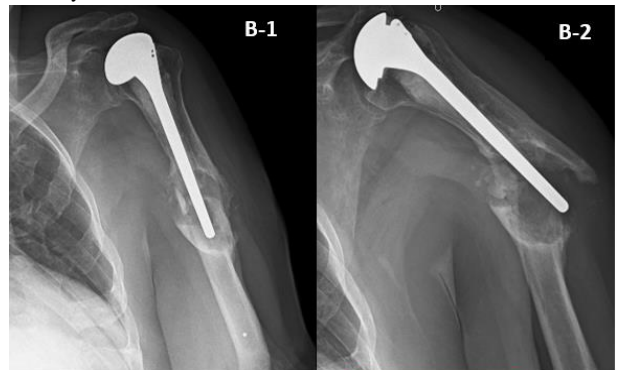
**Figure 3B:** X rays showing the nonunion in the site of the previous fracture. The head of the endoprosthesis has migrated upward, a sign meaningful of rotator cuff insufficiency.

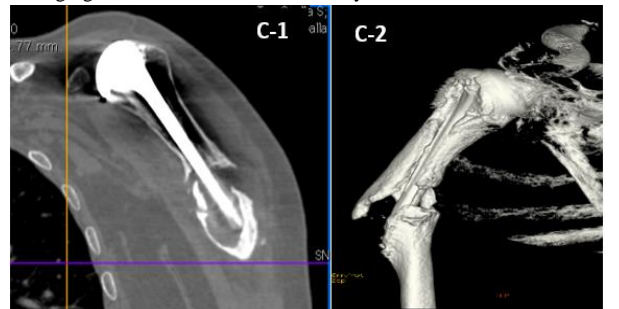
**Figure 3C:** CT-scan with 3D reconstruction highlighting an atrophic nonunion of the humeral shaft, with a significant bone gap.

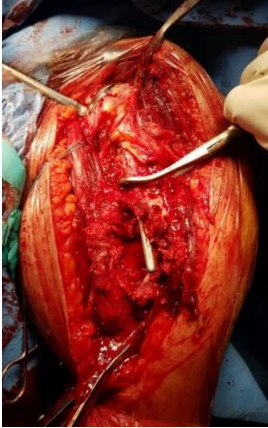
**Figure 4A:** Intra-operative image showing the previous implanted endoprosthesis, with the atrophic nonunion at the lower extremity. Notice the wide bone gap in the middle of the humers. An extended delto-pectoral approach was used.

The main goals of this reintervention were to treat the humeral shaft non-union and restore the shoulder function. It was decided to gain these aims in only one stage. After removing the previous prosthesis and its cement, fracture intramedullary fixation was obtained with the extra-long stem (180 mm) of the reverse shoulder arthroplasty (SMR model, LIMA corporate, Italy) we implanted to restore shoulder function. The extra-long stem was chosen to include and surpass the non-union site, which was bonified with an extensive curettage. Due to the relevant bone loss, an allograft from a cadaver femur, was prepared and fixed with two metal cerclages (Figure 4). The patient was dismissed with the upper arm

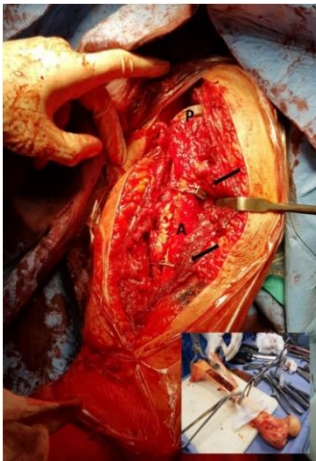
**Figure 4B:** In the square, preparation of the bone splint from the cadaveric femur. Intra-operative image showing the positioning of the allograft (A) and its fixation by metal cerclages (arrows). Notice the head of the reverse prosthesis (P), implanted before the fixation of the allograft.

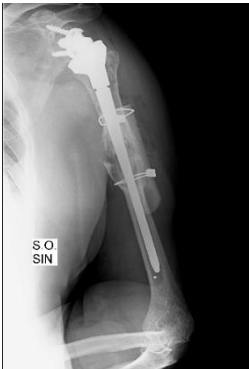
**Figure 5A:** Post-operative check, showing the correct positioning of the reverse prosthesis and the allograft.

immobilized by a sling for six weeks. Active kinesis for the elbow and the wrist were allowed. Passive kinesis of the shoulder started after six weeks. The patient underwent radiological and clinical examination every month (Figure 5), and 8 months after the intervention radiographical healing was obtained.

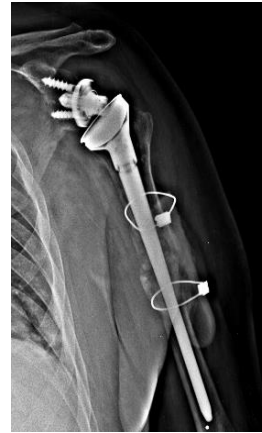
**Figure 5B:** 3 months radiological follow up, showing initial sign of consolidation.
